Naturalist Monitoring and Reports

WaterColor Ecological Services 2025

Prepared for:
WaterColor Community Association

Project/File:
172608824

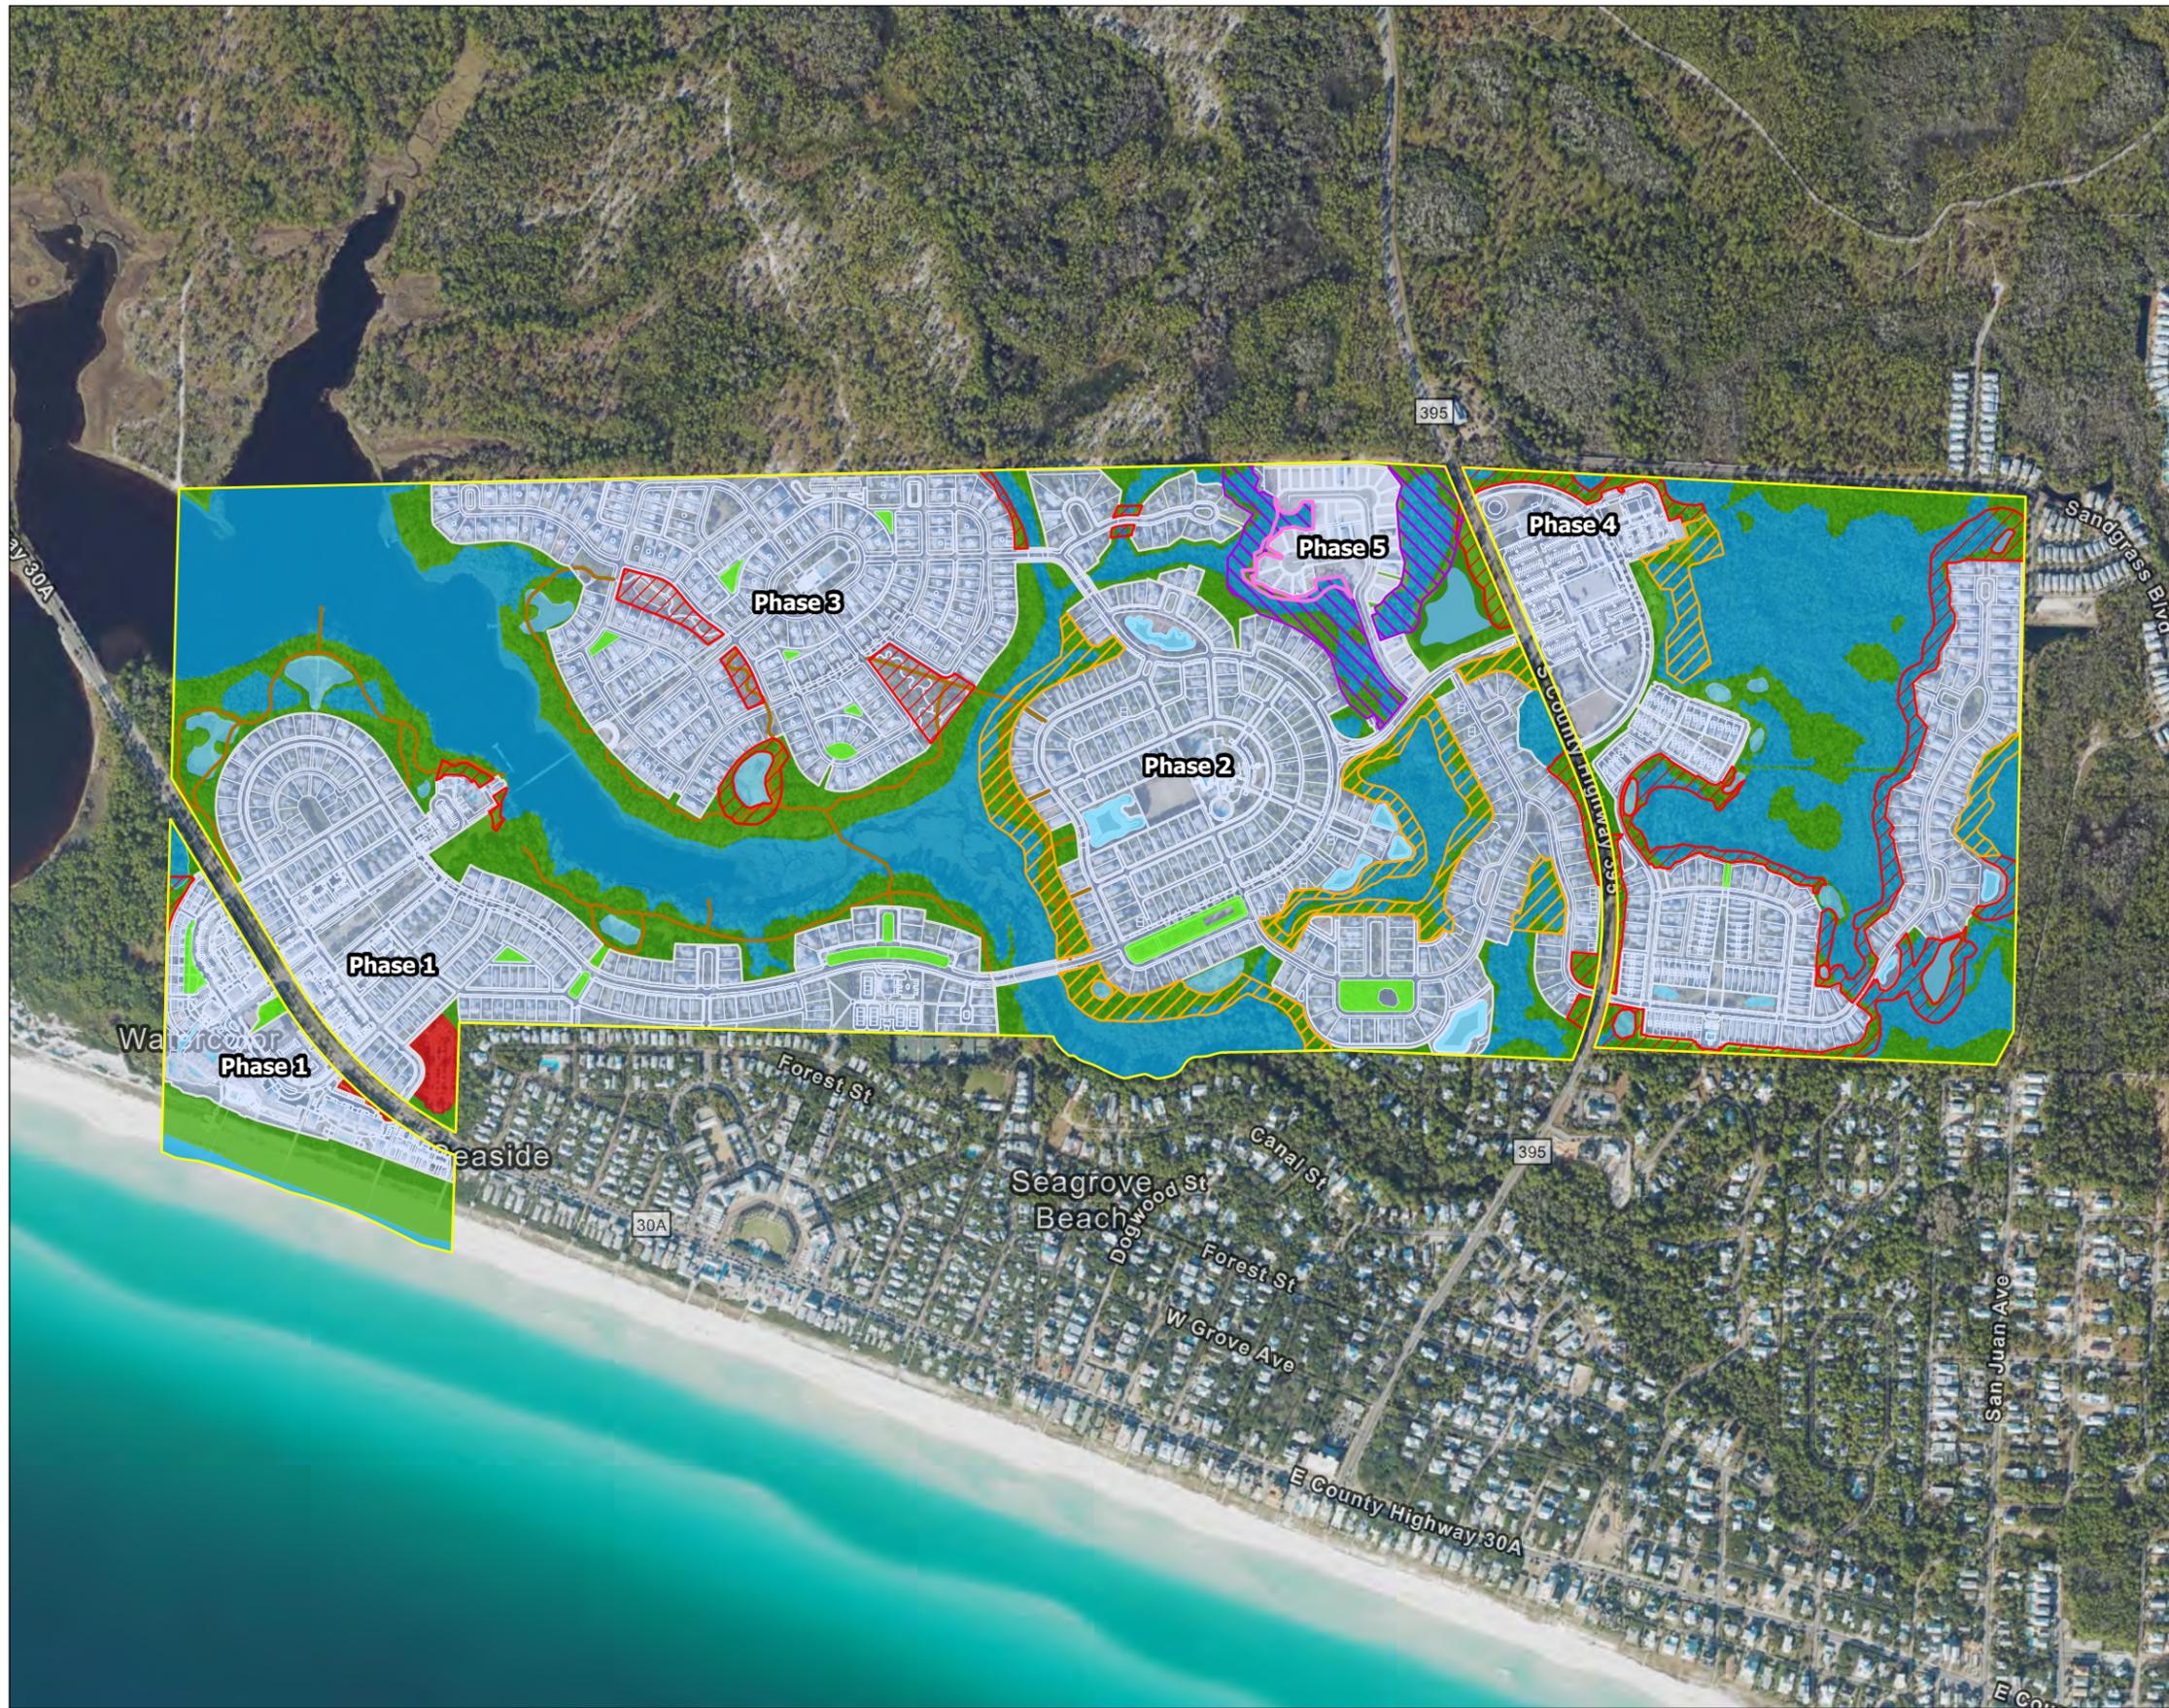
Figure No. **1**
Title **Land Management Activities 2025**

- Legend**
- Project Boundary - 500.49 ac.
 - 2025 Titi Thinning - 0.90 ac.
 - 2025 Pine Thinning/Bush Hogging - 10.14 ac.
 - 2025 Bush Hogging - 20.03 ac.
 - Yearly Bush Hogging - 22.54 ac.
 - Managed by Others - 1.79 ac.
- Common Open Space Lands**
- Native Trails
 - Native Pockets - 4.92 ac.
 - Stormwater Ponds - 10.84 ac.
- Natural Areas**
- Natural Area Uplands - 87.06 ac.
 - Natural Area Wetlands/Surface Waters - 133.67 ac.
- Estimated Phase Boundaries**
- Phase 1 - 68.36 ac.
 - Phase 2 - 73.73 ac.
 - Phase 3 - 67.93 ac.
 - Phase 4 - 51.66 ac.
 - Phase 5 - 8.67 ac.

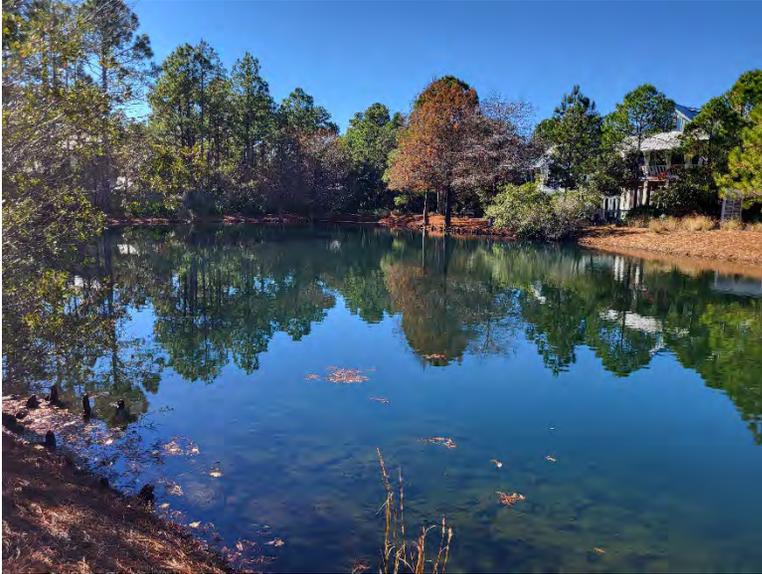
1. Typical stormwater pond.

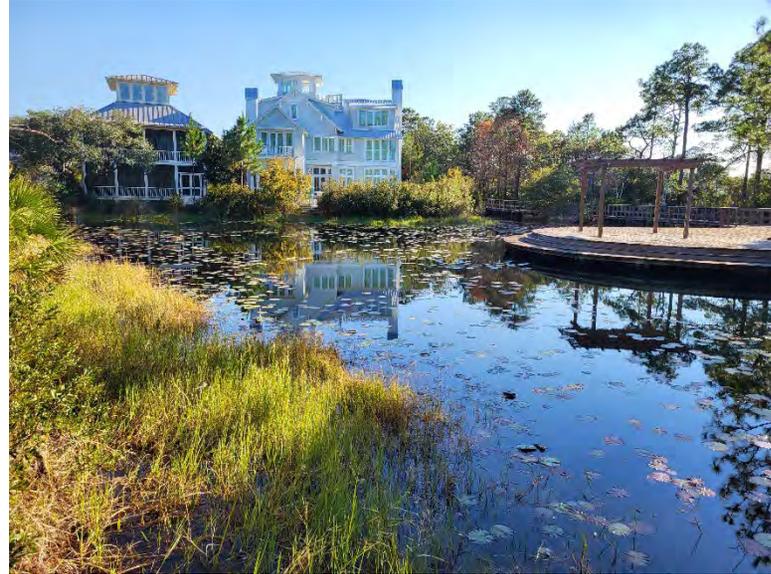
2. Typical stormwater pond, torpedo grass present on left.

Storm water ponds inspected were noted to have a less than 5% coverage by exotic and nuisance species, though torpedo grass was observed in multiple ponds. Continued management efforts to further reduce exotic and nuisance plant occurrences within WaterColor are planned for 2026. A strict policy of planting only native plant species and non-native species that are not documented as nuisance species remains in place.

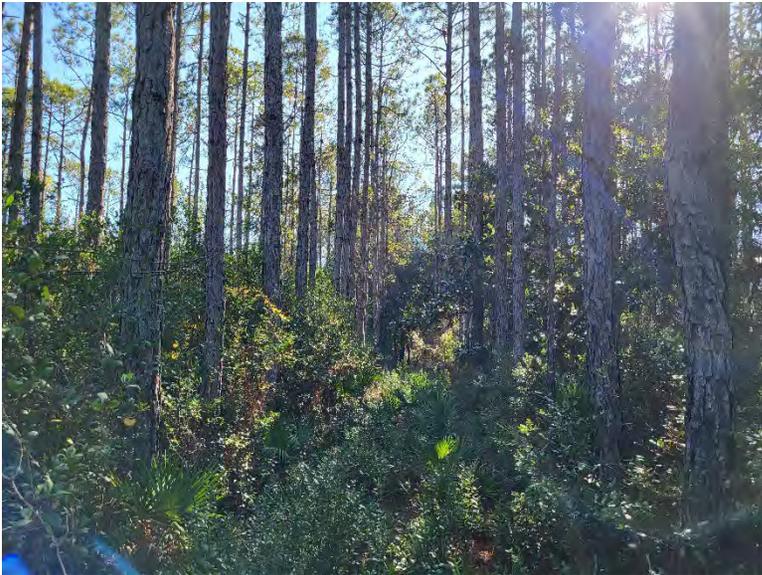
3. Rowed pine bordering the USACE enhancement area.

A dense canopied slash pine border remains around most of the enhancement area, with little evidence of pine thinning. The central wetland area contained a relatively open canopy layer consisting of sparse slash pine and a small stand of swamp tupelo (*Nyssa biflora*). Twelve (12) pond cypress, previously planted in 2020, were observed to have survived.

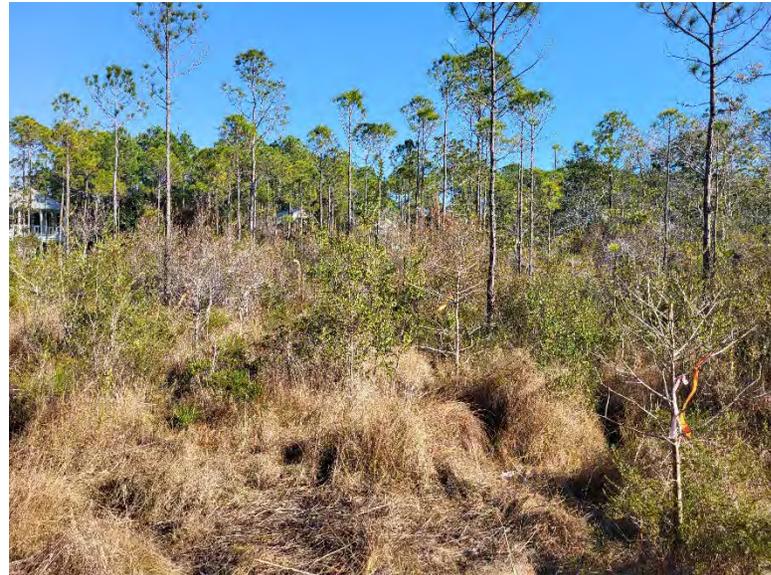
4. USACE enhancement area.

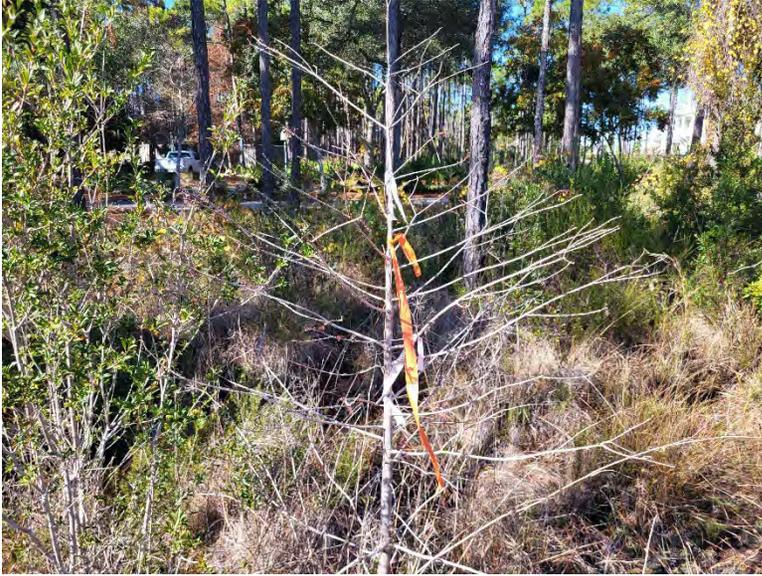
5. Planted cypress within the USACE enhancement area.

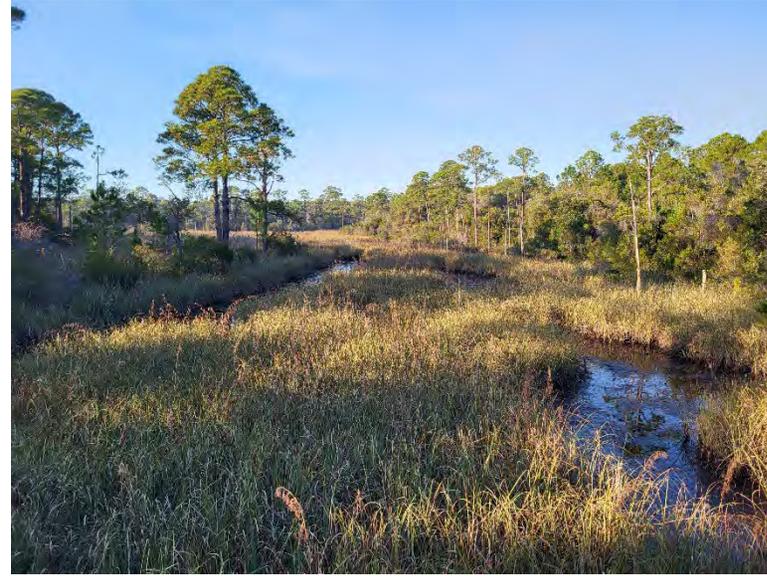
6. Western Lake, looking NW from Western Lake Drive.

Exotic and nuisance plant species described in Section 4.5 were observed within Phases I-IV. Cattails were observed in the eastern portion of Western Lake, crossing under the eastern boardwalk and along the shoreline. Future land management efforts should target these areas.

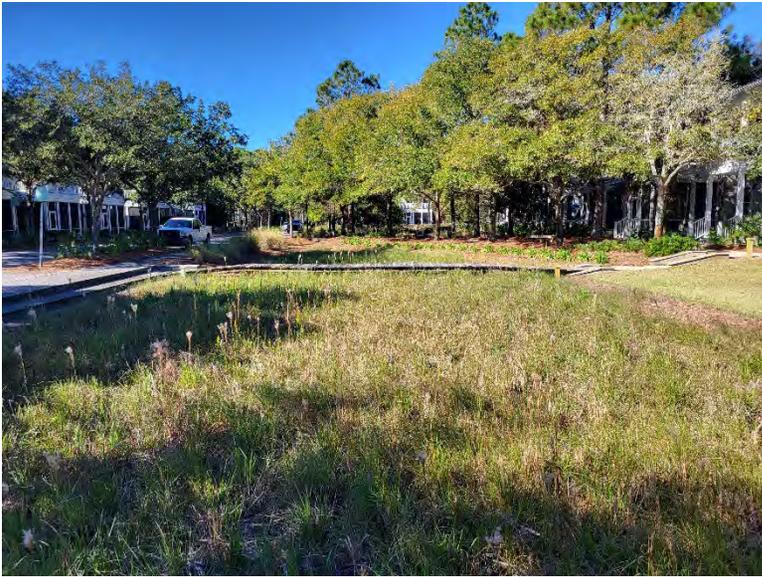
7. Herbaceous wetland, Phase IV.

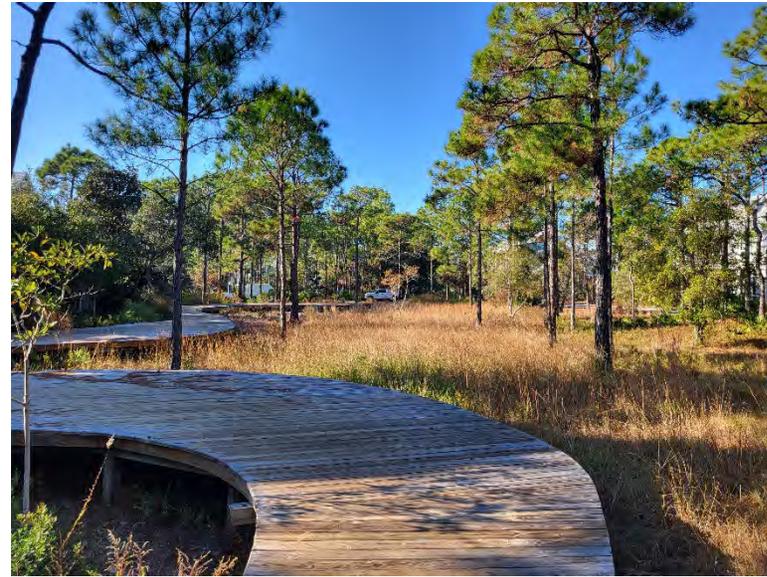
8. Typical maintained upland space, Phase III.

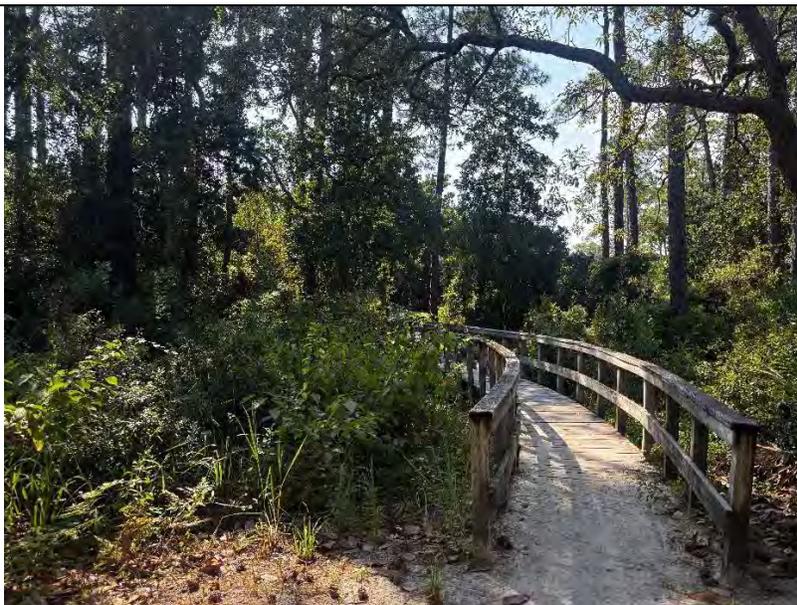
Photopoint: 2
Phase: 1
Date: September 20, 2025

Description: A boardwalk along the Bicycle/Pedestrian trail. Area mowed in 2024. Shrubs and vines regrowing rapidly. Somewhat weedy vegetation, but in good condition.

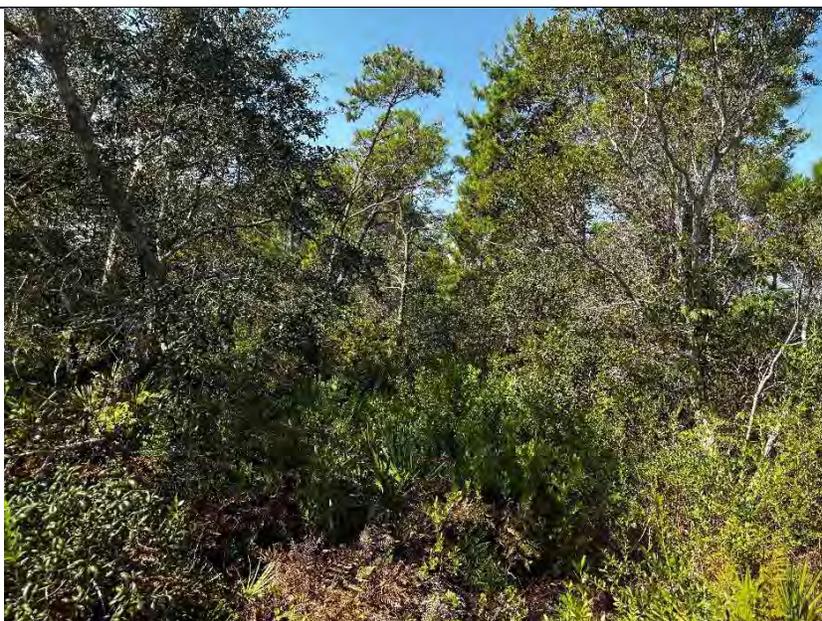
Photopoint: 3
Phase: 1
Date: September 20, 2025

Description: Natural area along the margin of Western Lake. Former scrub sloping down to a small ecotone of pine flatwoods along the lake edge. Not mowed this year. Good mix of 2-5 ft shrubs, palmetto and bracken. Royal fern still present. Poison ivy on rail should be removed.

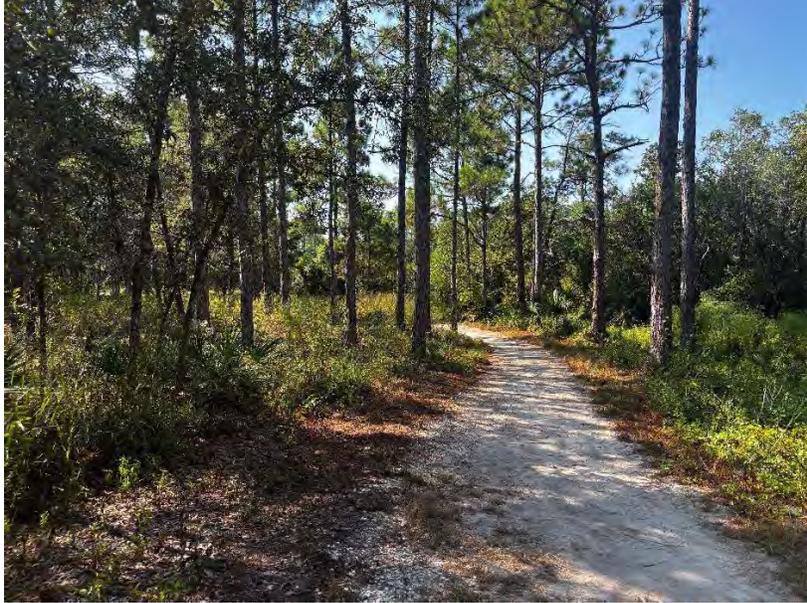
Description:
Bicycle/Pedestrian trail along the west side of Phase 2. The area is regularly mowed, resulting in a low stature understory.

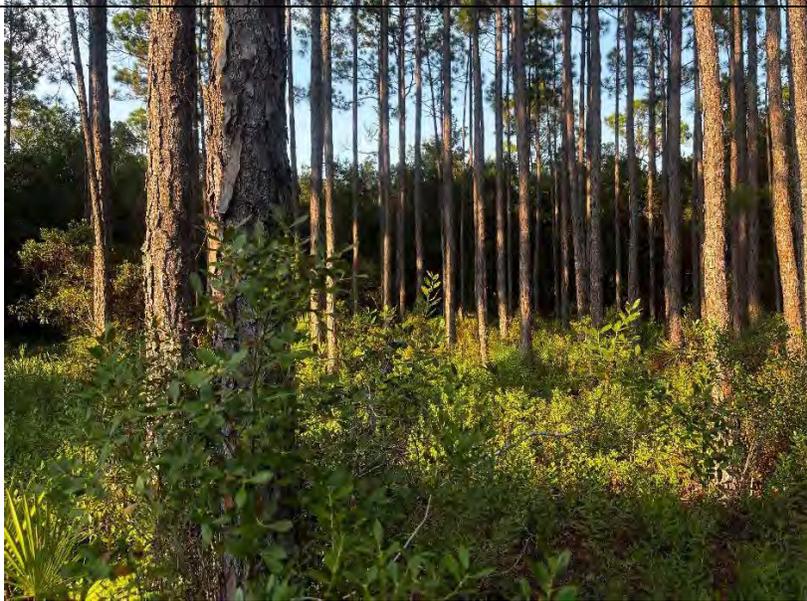
Photopoint: 5
Phase: 2
Date: September 20, 2025

Description: Area of planted pine behind homes off of Thicket Circle. Pines at a good density. Good condition. The paint can seen last year has been removed.

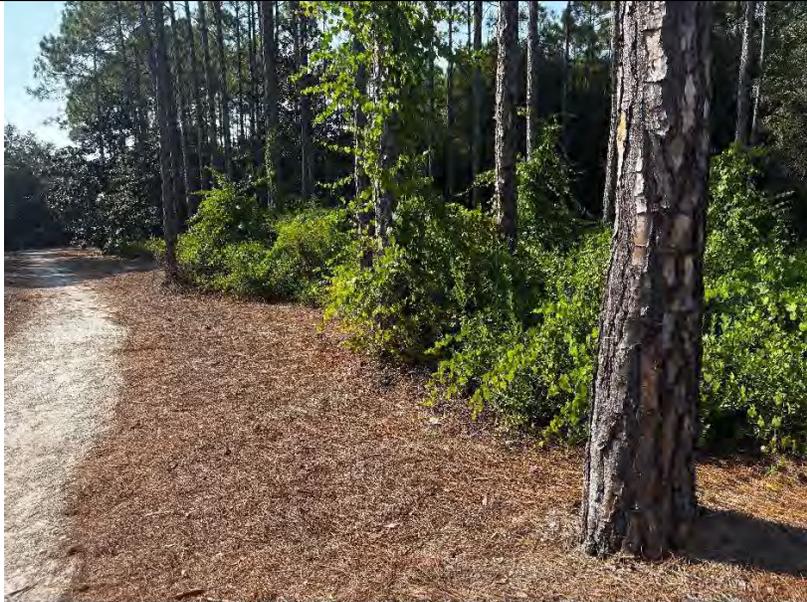
Photopoint: 6
Phase: 2B
Date: September 19, 2025

Description: Planted pines along the trail between Royal Fern Way and Pine Needle Way. Vegetation similar to 2024. According to Mr. Anderson, 10-12 pines were removed for access in this area, and it was mowed this year. The muscadine has grown aggressively since January.

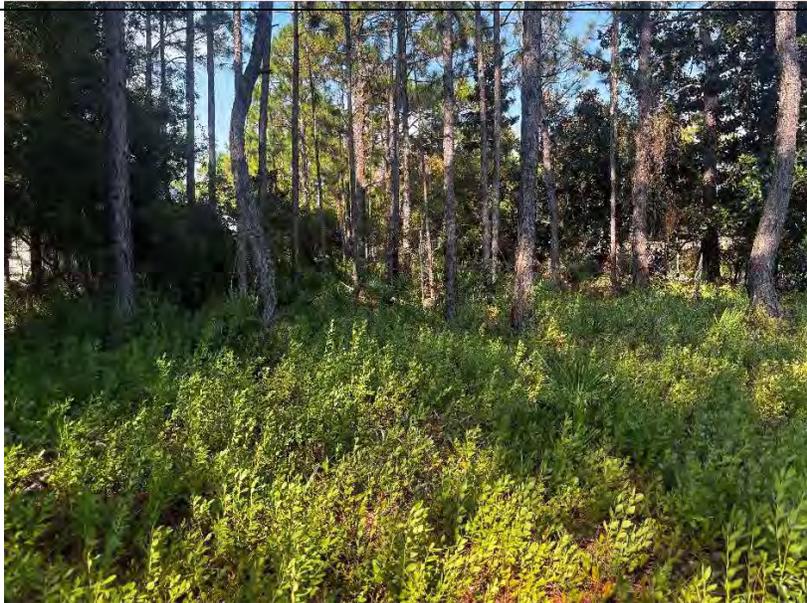
Photopoint: 21 (new)
Phase: 2B
Date: September 19, 2025

Description: Natural area between Royal Fern Way and Hwy 395. Mechanical treatment this year. Good condition and muscadine vines in check.

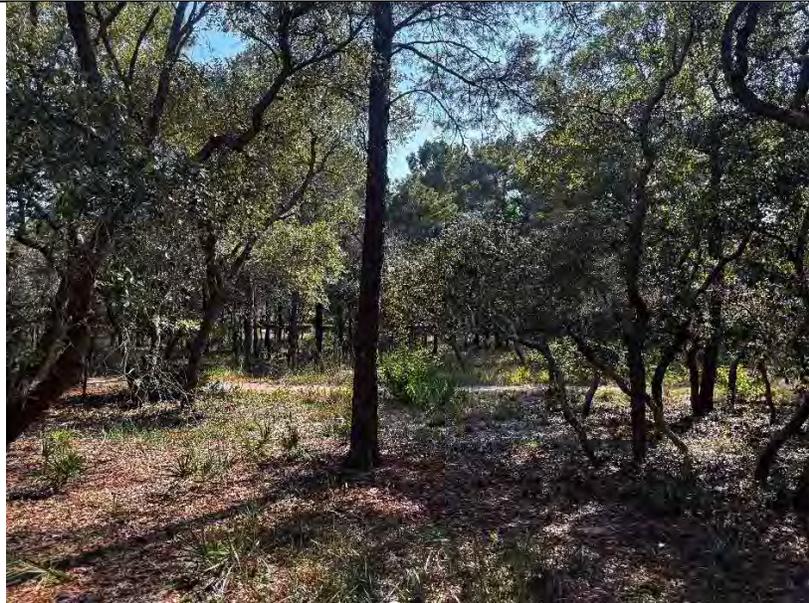
Description: Park area of sandhill vegetation off of Scrub Oak Circle. This area is mowed yearly and appears relatively unchanged from the condition in 2023 and 2024.

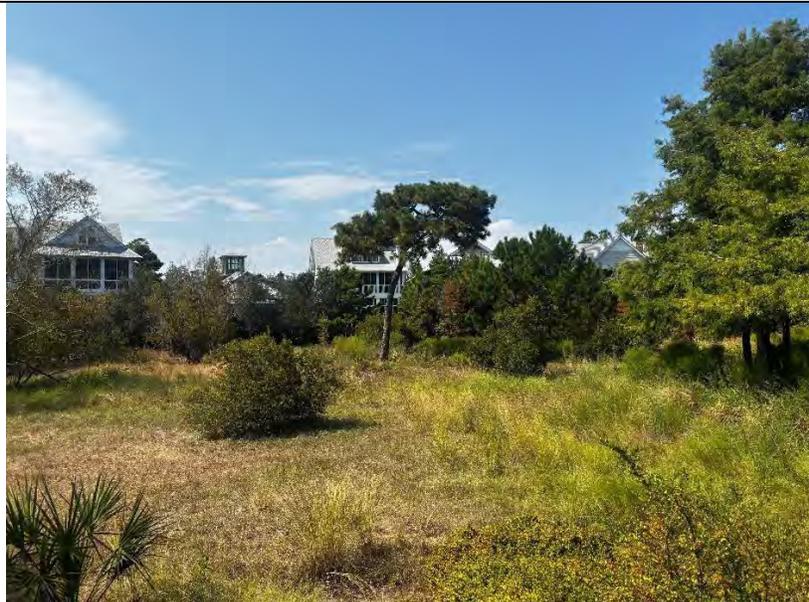
Photopoint: 8
Phase: 3
Date: September 20, 2025

Description: View across a dry pond. This area had standing salt water for several months in 2014 that killed a stand of sand pines. The area has been planted with an attractive set of native species and is doing well.

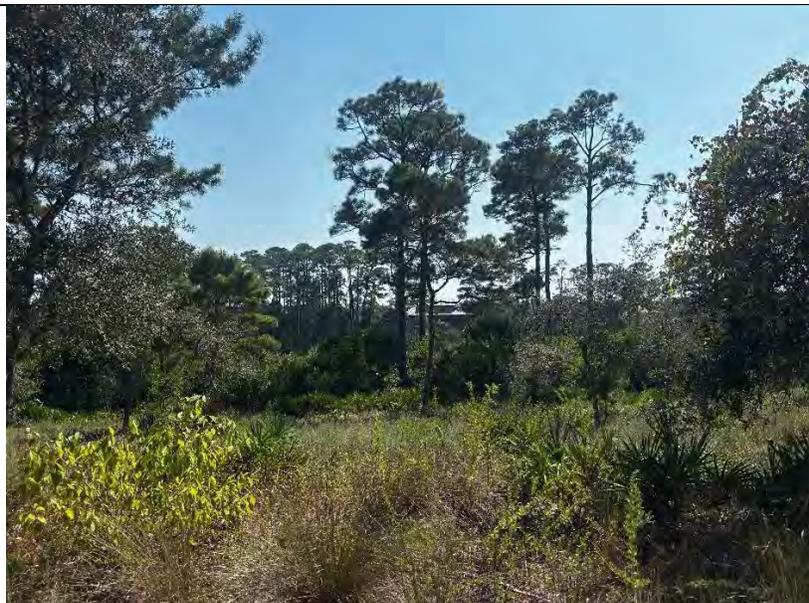
Photopoint: 9
Phase: 3
Date: September 20, 2025

Description: Looking across recently mowed sandhill vegetation to the west finger of Western Lake. The frequent bush hogging keeps fuel loads down and opens up natural views across the lake. Not bush hogged this year.

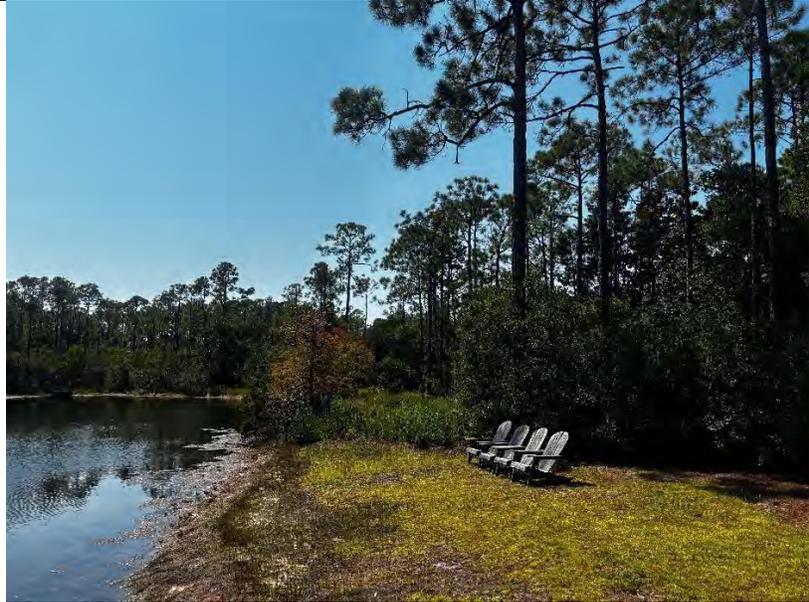
Description: Eastern edge of large stormwater pond off of Pine Lily Circle.

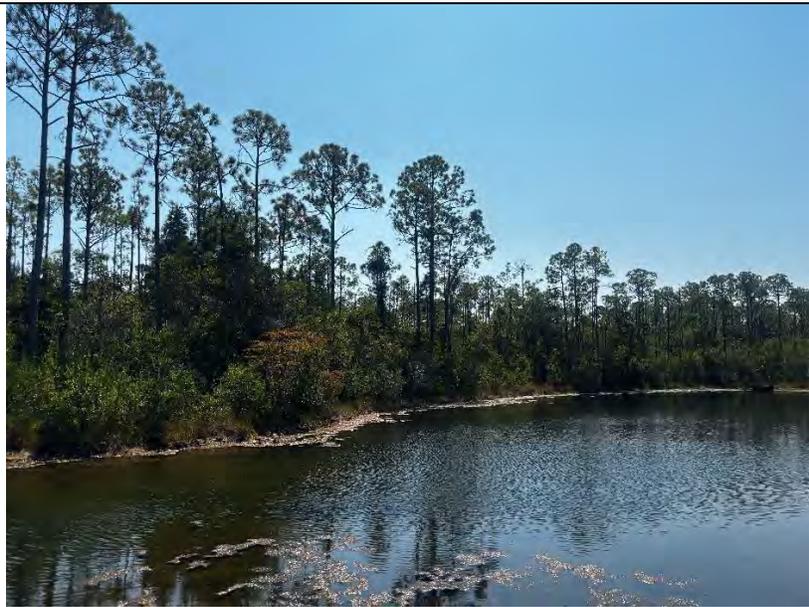
Photopoint: 11
Phase: 4
Date: September 19, 2025

Description: Large stormwater pond off of Pine Lily Circle. The surrounding natural land is not actively managed by the Association, but the edges of the pond appear very natural.

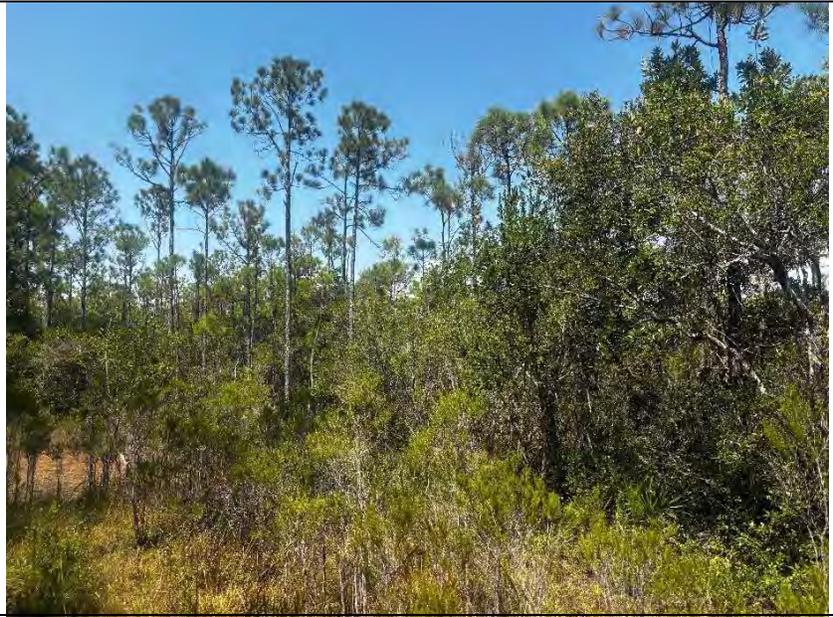
Photopoint: 12
Phase: 4
Date: September 19, 2025

Description: Swale adjacent to homes on Sunflower Circle. This small area appears recently. The whole area retains a diversity of high-quality native species. The wet flatwoods beyond the swale is in good condition, although pine and titi densities are high.

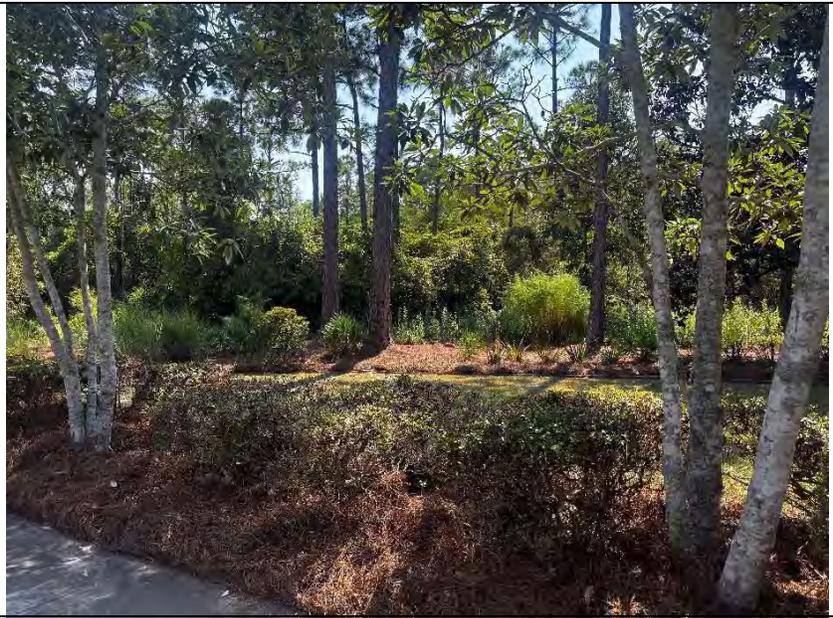
Photopoint: 13
Phase: 4
Date: September 19, 2025

Description: Looking from Winterberry Circle across sodded area into natural wetland. Titi is regaining dominance after some removal in 2021. Deer were seen moving through this area during the site inspection, and the wetland was inundated.

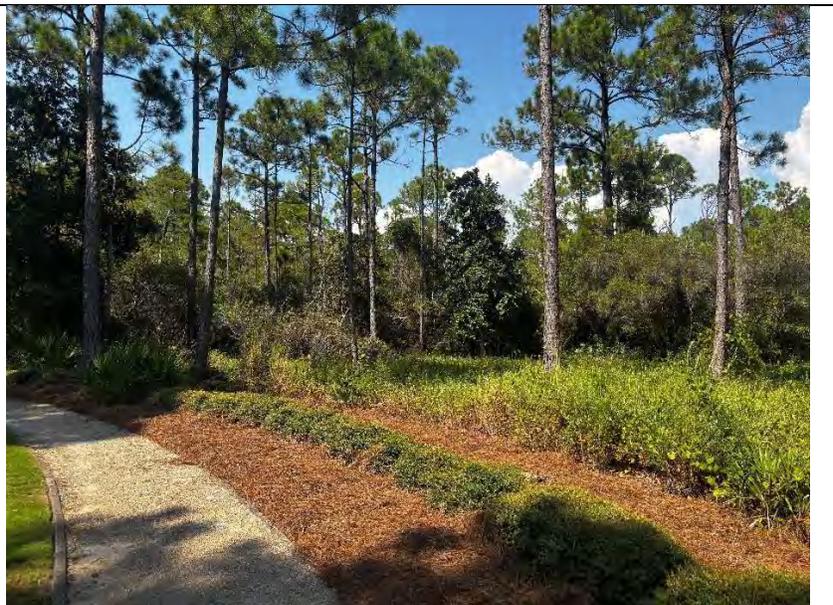
Photopoint: 14
Phase: 4
Date: September 19, 2025

Description: Flatwoods vegetation receives frequent mechanical treatment that has reduced fuel levels and muscadine vine density. Torpedograss is invading areas of native vegetation.

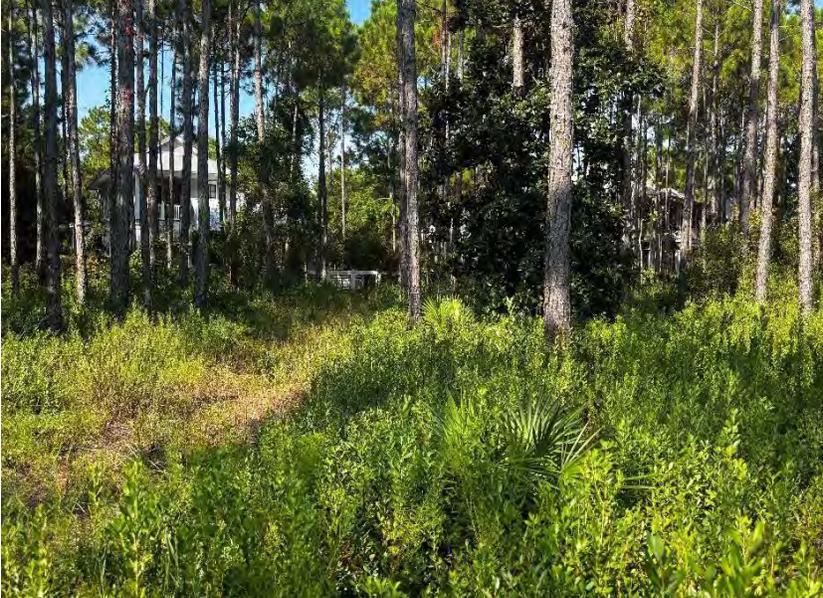
<p>Photopoint: 15 Phase: 5 Date: September 21, 2025 Latitude: 30.327229 Longitude: -86.128898 Direction: West Description: Planted pine stand between Phase 2 and 5 with a little cypress and flatwoods understory. Mowed recently with torpedograss invading.</p>

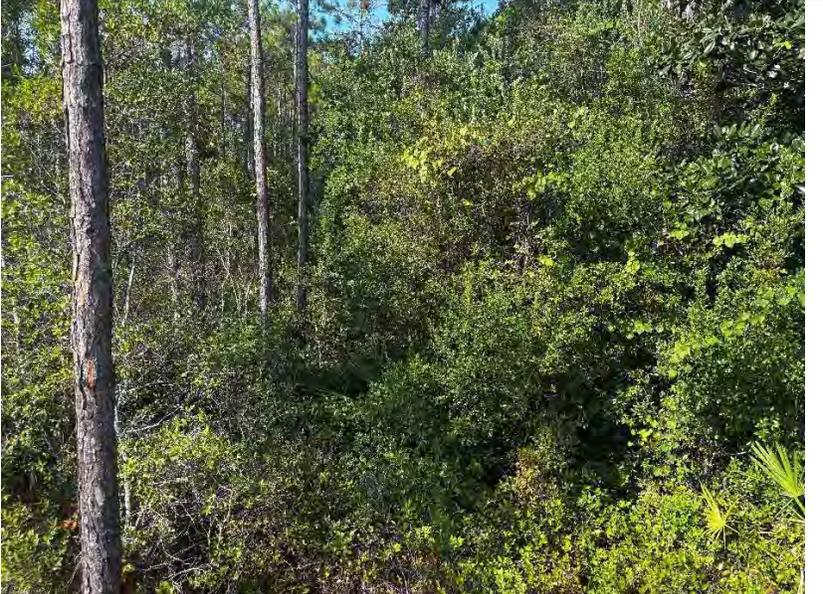
<p>Photopoint: 16 Phase: 5 Date: September 21, 2025 Latitude: 30.327818 Longitude: -86.129241 Direction: West Description: Planted pine stand between Phase 2 and 5 in wet flatwoods with dense titi.</p>

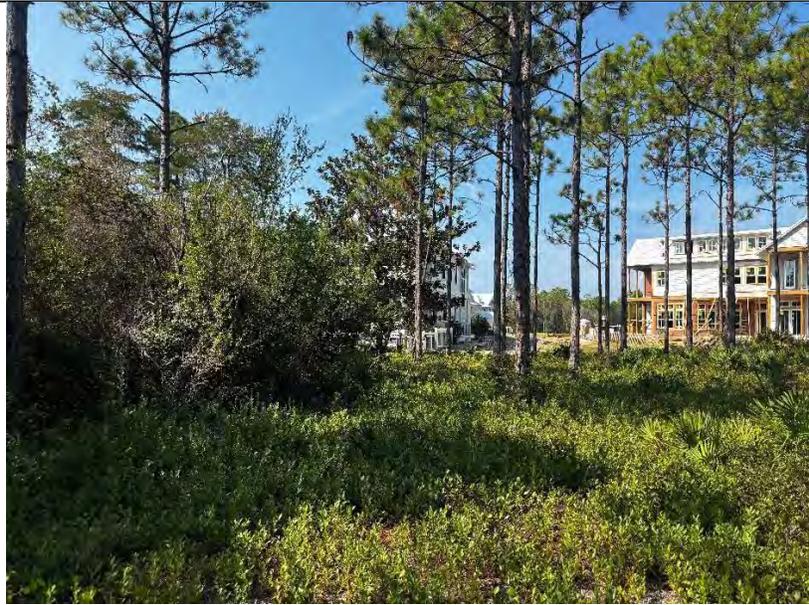
Description: Mowed flatwoods vegetation with a good mix of native species. Both longleaf and slash pine in canopy.

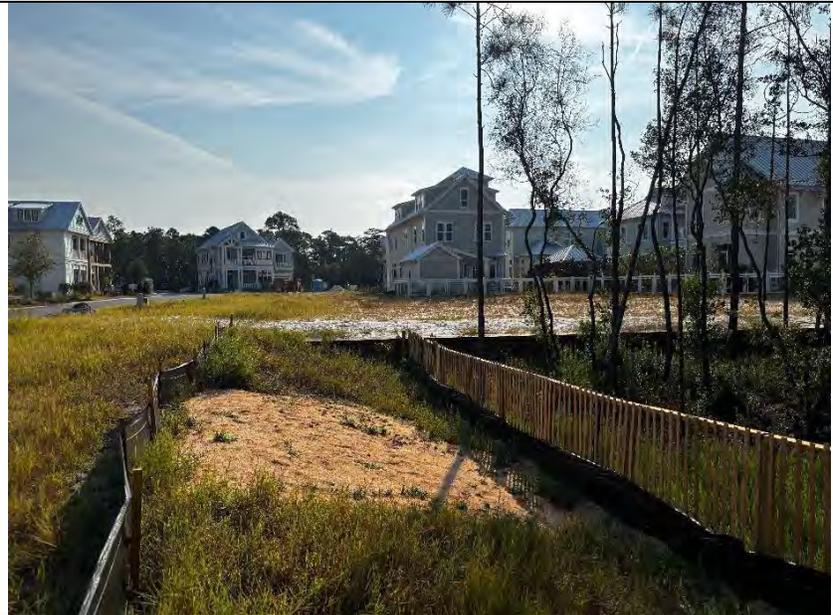
Photopoint: 18
Phase: 5
Date: September 21, 2025

Description: North edge of titi bog with torpedograss infesting fill soil along slope down to wetland. New silt fencing and a fence on north edge of wetland has been installed.

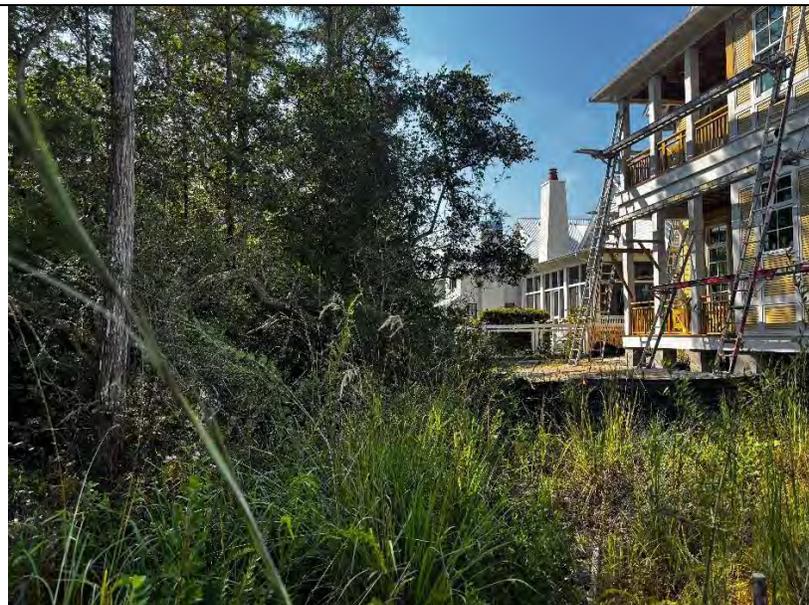
Photopoint: 19
Phase: 5
Date: September 21, 2025

Description: Construction along edge of small cypress swamp. Cypress trunk on left side of photo.

- Remove construction materials on pine trees in Phase 5.
- Increase awareness of free roaming cats and remove when possible.
- For cultivated areas, avoid the use of invasive plant species from the FISC list (<https://floridainvasivespecies.org/plantlist2019.cfm>).

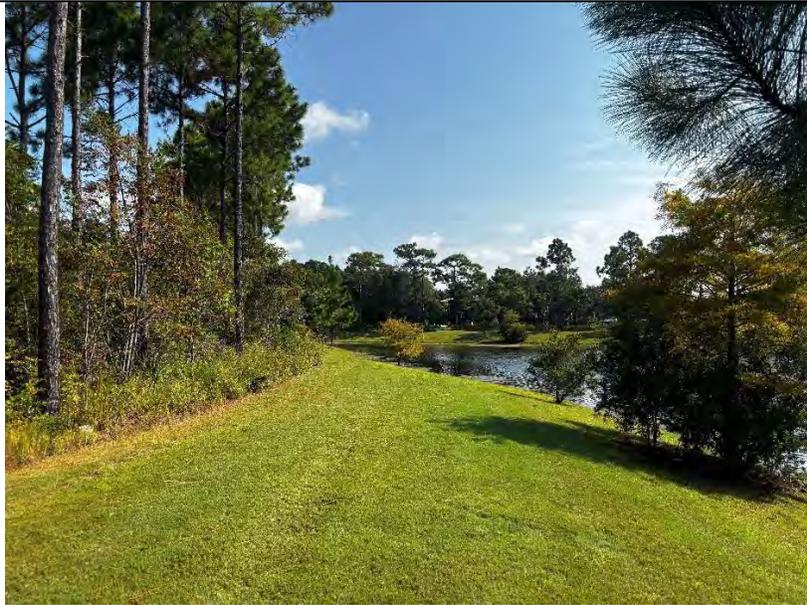
Photopoint: 20
Phase: 5
Date: October 6, 2024

Description: Landscaped edge of retention pond in Phase 5. Slash pine stand on left plus planted cypress and sweetbays around pond in mowed area. Torpedograss on edge of pond and flatwoods.

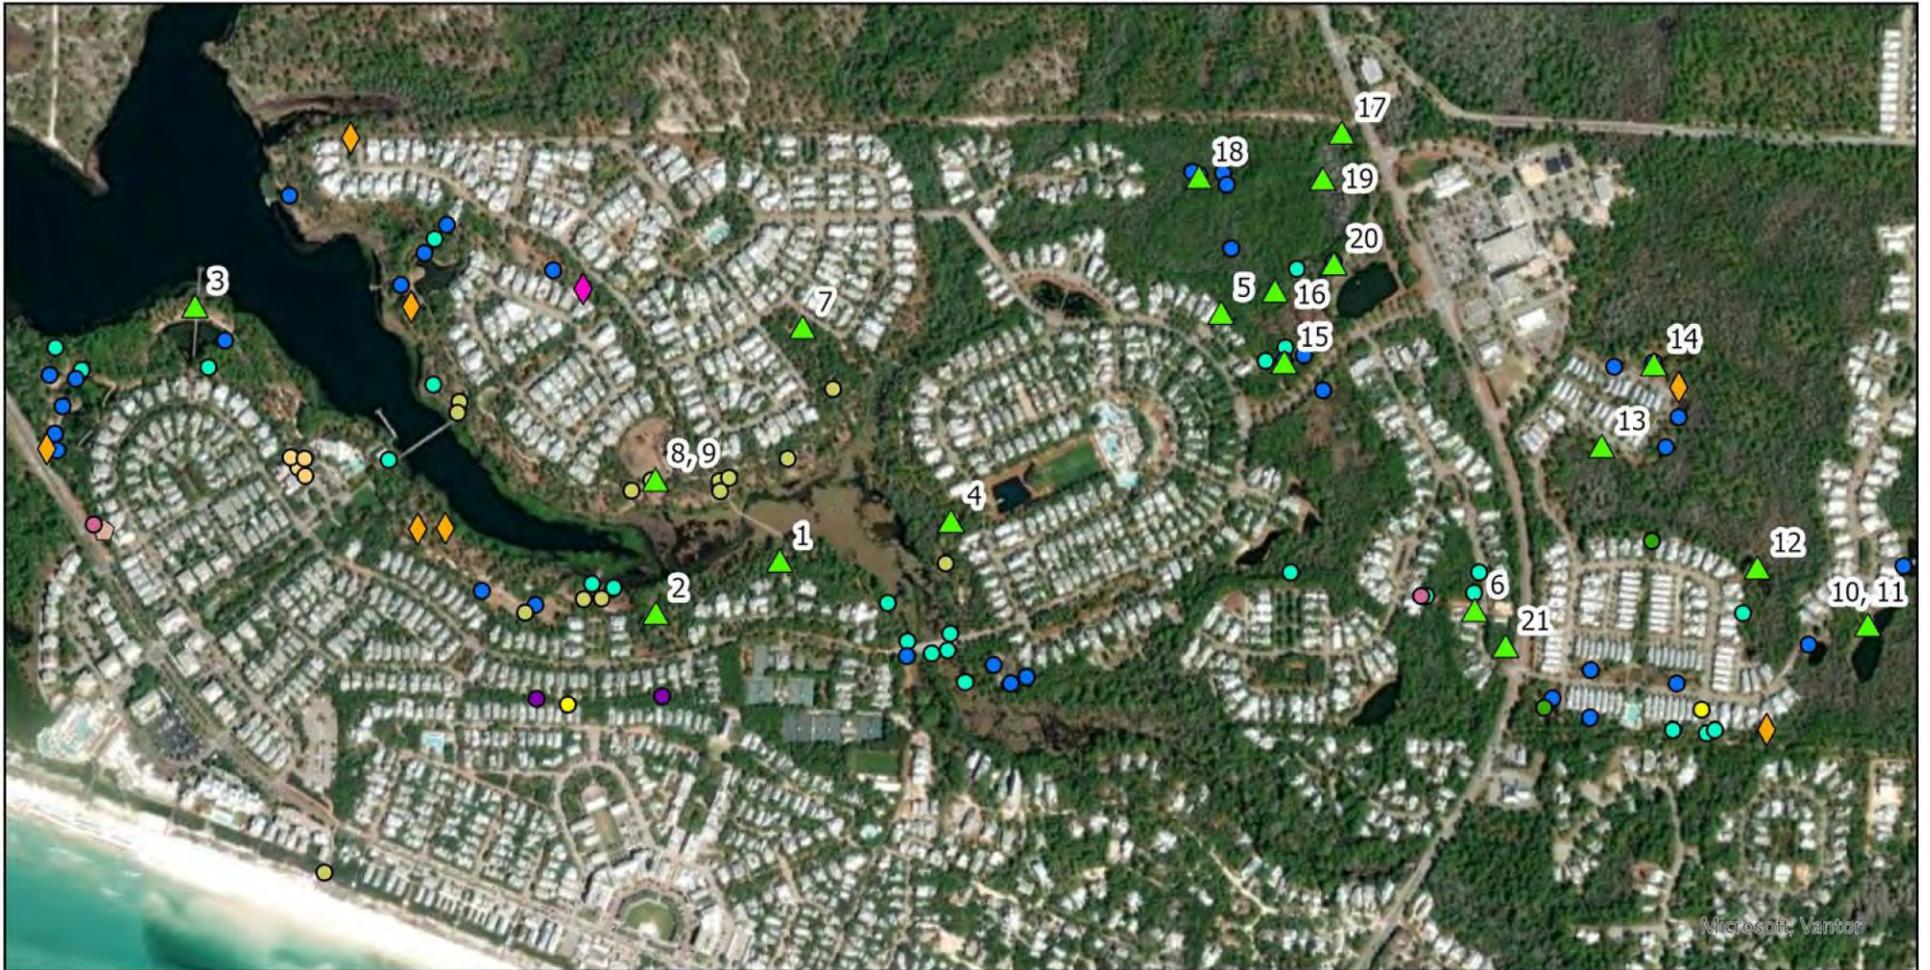
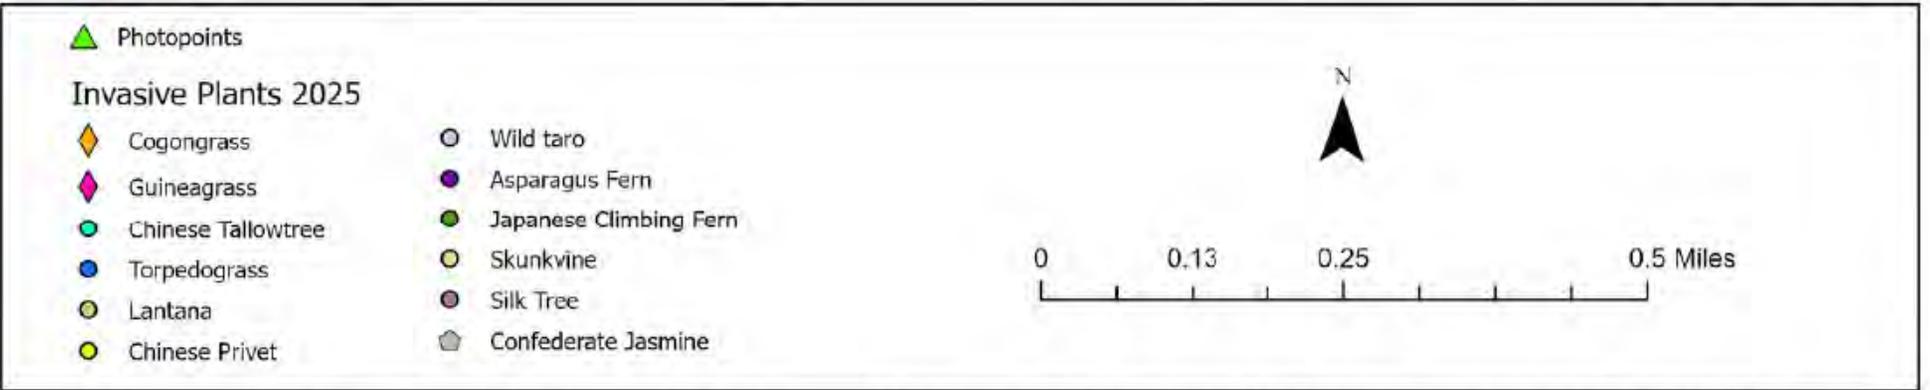
Figure 1. Photopoint locations and non-native invasive plant species seen during a survey of the WaterColor Development on September 19 - 21, 2025.
